## **TECHNICAL BULLETIN**

**021**

**January 2018**

### *BACKUP RING PXI VAM 9.850-265.0 (old 000905)*

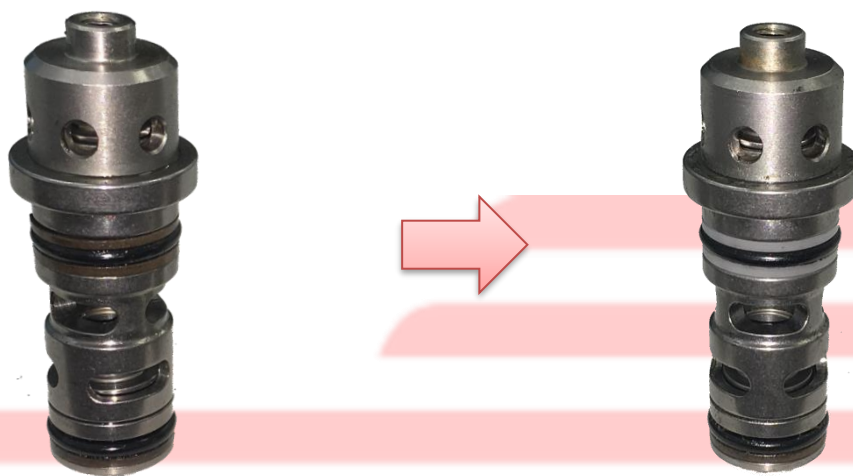
- *Modification of material on 2 backup rings 9.850-265.0 placed in the VAM center cartridge 1.099-704.0 (old 360407) and 1.099-703.0 (old 360406) of the PXI pumps;*
- *This new material improves significantly the durability of the O-ring between the 2 backup rings; visually the new backup ring is white*
- *The new backup ring is interchangeable with the previous one.*

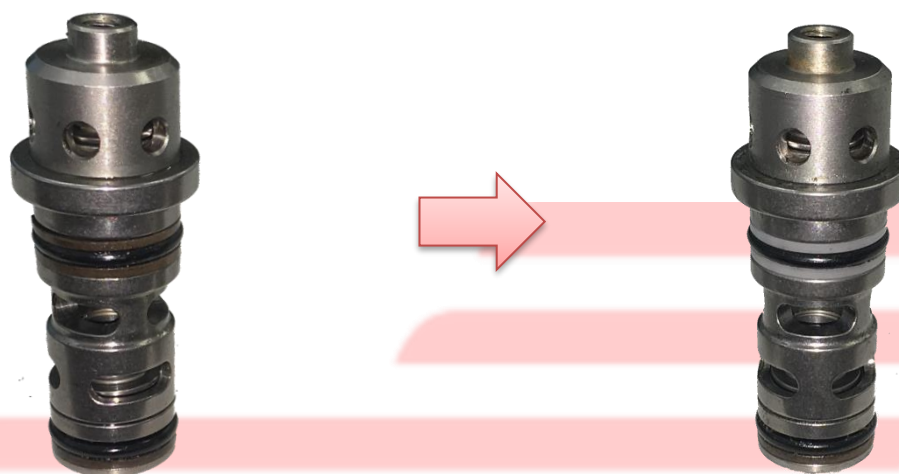
- E' stato cambiato il materiale dei 2 anti estrusore 9.850-265.0 posti in centro alla cartuccia VAM 1.099-704.0 (vecchio 360407) e 1.099-703.0 (vecchio 360406) delle pompa PXI
- Il nuovo materiale migliora sensibilmente la durata dell'anello OR incluso tra i 2 anti estrusori; visivamente il nuovo anti estrusore è di colore bianco
- Il nuovo anti estrusore è intercambiabile con il precedente.
